Manhole Inspection Summary

Manhole # S27C__041MH

Location Address: **914 SARAH ANN ST**

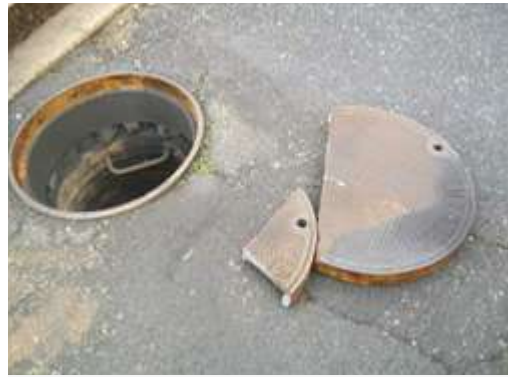
CUT OPEN LID WITH SAW

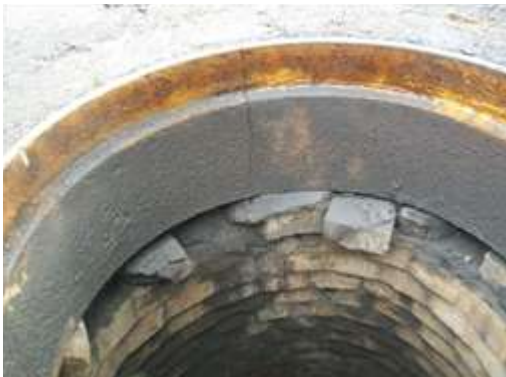
Defect 2

Frame Offset: **0** (in.) Condition: ☐ Sound ☒ **Cracked** ☐ Leaks

FRAME IS CRACKED

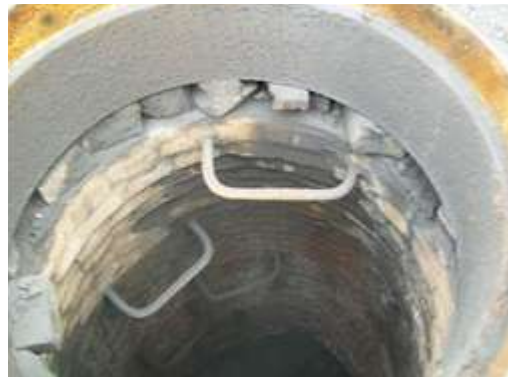
Defect 1

Condition: ☐ Sound ☒ **Cracked** ☐ Root Intrusion ☒ **Loose Brick** ☒ **Deteriorated**

4" CHIMNEY HAS LOOSE AND MISSING BRICKS

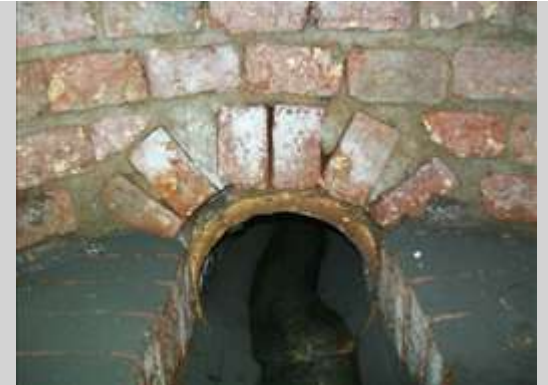
12 O'Clock Outflow

8 in. Circular Gravity Sewer
Pipe Out @ 12 O'Clock

Invert Depth: **9.01** (ft.) Flow Characteristics: **Slow**

Infiltration: **None**

Pipe Seal Cond: **Sound**

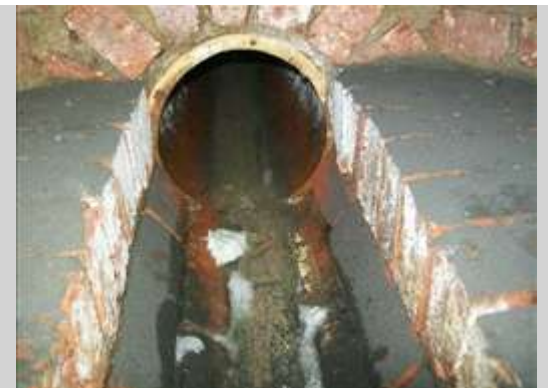
6 O'Clock Inflow

8 in. Circular Gravity Sewer
Pipe In @ 6 O'Clock

Invert Depth: **8.92** (ft.) Flow Characteristics: **Slow**

Infiltration: **None**

Pipe Seal Cond: **Sound**
